GIWW Bank Restoration of Critical Areas in Terrebonne (TE-43)

Project Status

Approved Date: 2001 **Cost:** \$1.74 million
Project Area: 3,324 acres **Status:** Engineering and Design
Net Benefit after 20 Years: 366 acres
Project Type: Shoreline Protection

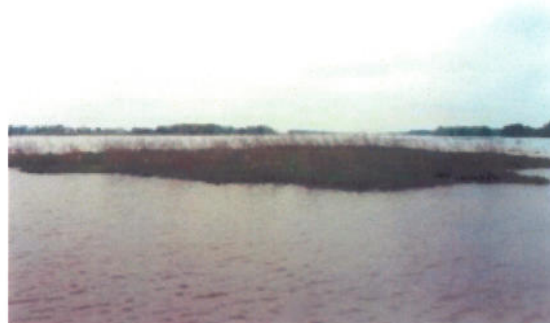
Large mats of floating freshwater marsh, such as this one, detach from their point of origin and enter the GIWW through large breaches in the existing shoreline.

In the past 20 years, as the efficiency of the Lower Atchafalaya River has decreased, Verrett subbasin flooding and Atchafalaya River flows via the Gulf Intracoastal Waterway (GIWW) have increased. Deterioration of fresh and intermediate wetlands, particularly of the floating marshes in the upper Penchant basin, has been attributed to sustained elevated water levels. In addition, floating marshes in some areas have become directly exposed to increased circulation through unnatural connections formed where channel banks deteriorated.

Conversely, losses in the central Terrebonne Parish marshes have been attributed to the elimination of riverine inflow coupled with subsidence and altered hydrology from canal dredging that facilitated saltwater intrusion. Increased flow of the GIWW and wave pulses from navigation traffic are causing additional breakup and loss of floating marshes in unprotected areas.

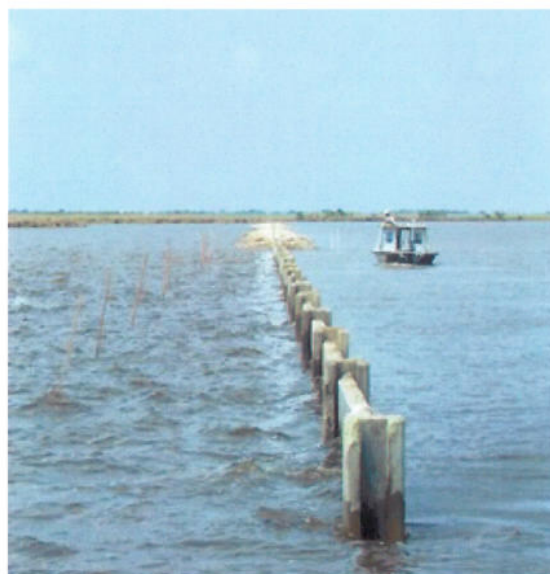
Concrete "H" pile/panel structures, similar to this one, will be installed at locations within the project area where shoreline erosion is critical. Soils with high amounts of organic material, which have poor strength, necessitated the use of a structure such as this.

This project will restore critical lengths of deteriorated channel banks and stabilize/armor selected critical lengths of deteriorated channel banks with hard shoreline stabilization materials.

Geotechnical soils investigation report is complete. Soils in the area are very soft and fluid.
